Chevrolet SSR

Subject: ASI Resolution - Tonneau Cover (Roof) Does Not Open Evenly or Will Not Open (Install Bushing)
#05-08-67-005A - (10/18/2005)

Models: 2003-2005 Chevrolet SSR - [Built Prior to VIN Breakpoint 4B108184](#)

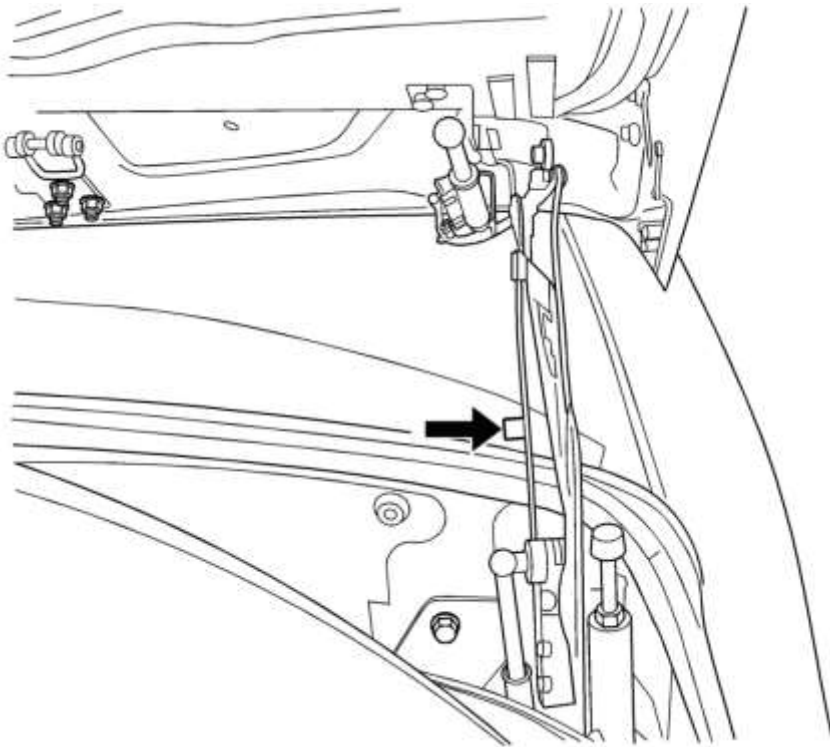
Some customers may comment that the roof/tonneau cover does not open evenly or the roof/tonneau cover won't open.

The hinge may be sticking on a rubber bushing attached to the hinge. Refer to the illustration.

Remove the rubber bushing on the hinge and install a new **delrin** bushing to the hinge.
Parts Information
